FINAL REPORT

ACCIDENT
self-launching powered glider
Arcus M registration marks HB-2503,
Col Ferret, Courmayeur (Aosta, Val d'Aosta),
August 12th, 2015

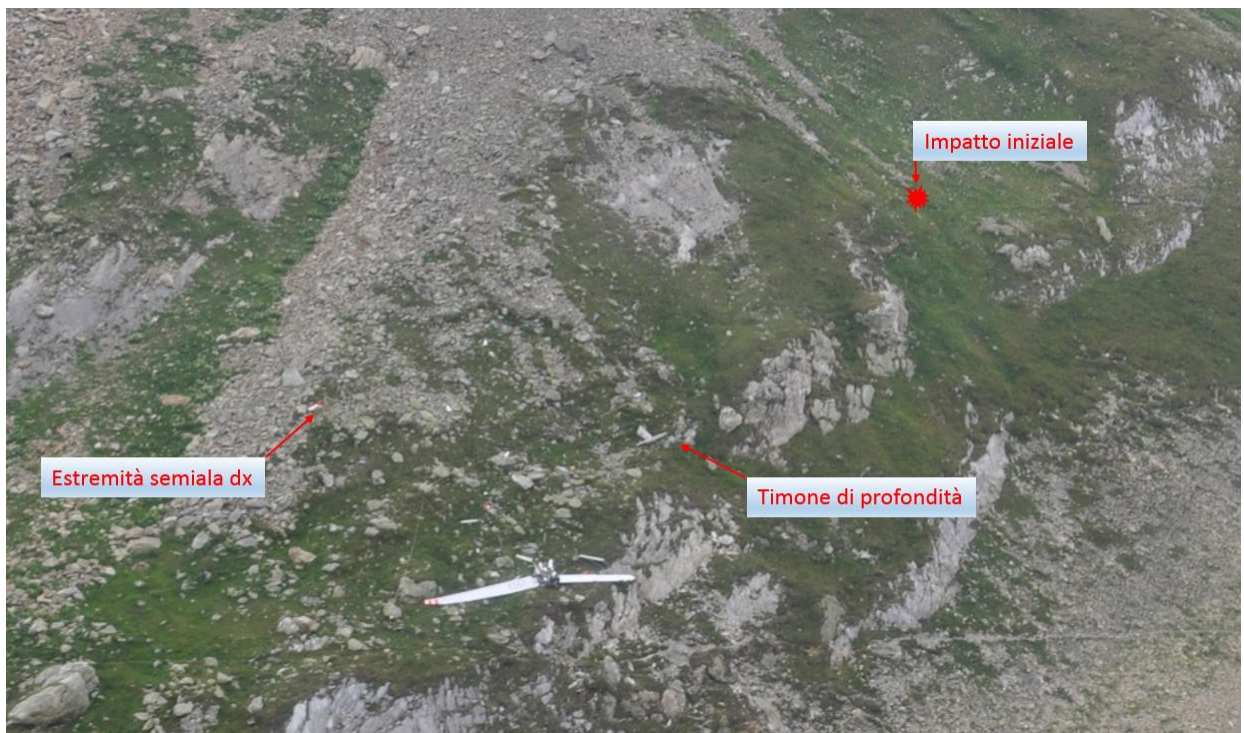
The glider impacted the western slope of Petit Col Ferret, at geographical coordinates 45°53'50.76"N 07°04'0.49"E (photo 1). At the first point of impact, parts of the front lower fuselage were buried in the ground (photo 3).

Between the first point of impact and the main wreckage, several parts separated from the glider, in particular the final part of the tail and the final section of the right wing (photo 1).

Photo 1: point of impact and wreckage distribution.

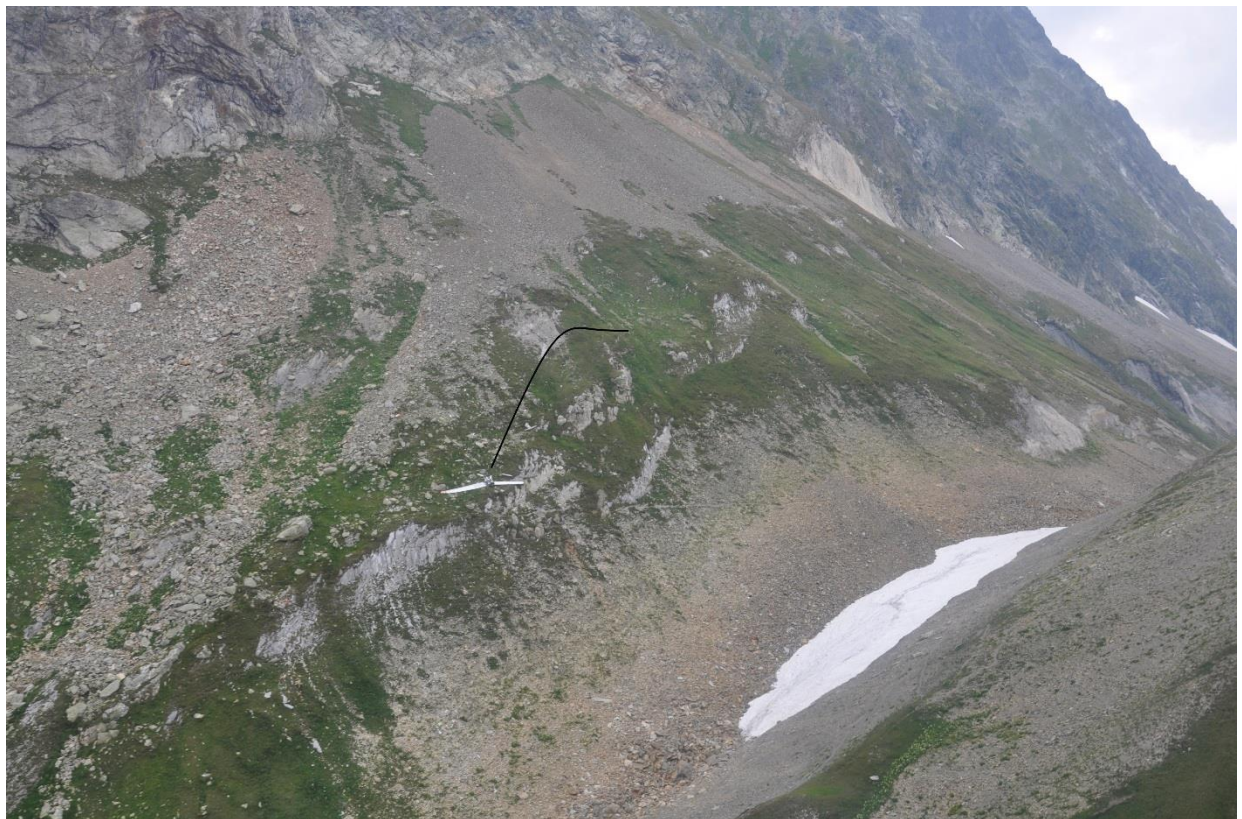
Photo 2: glider ground trajectory.

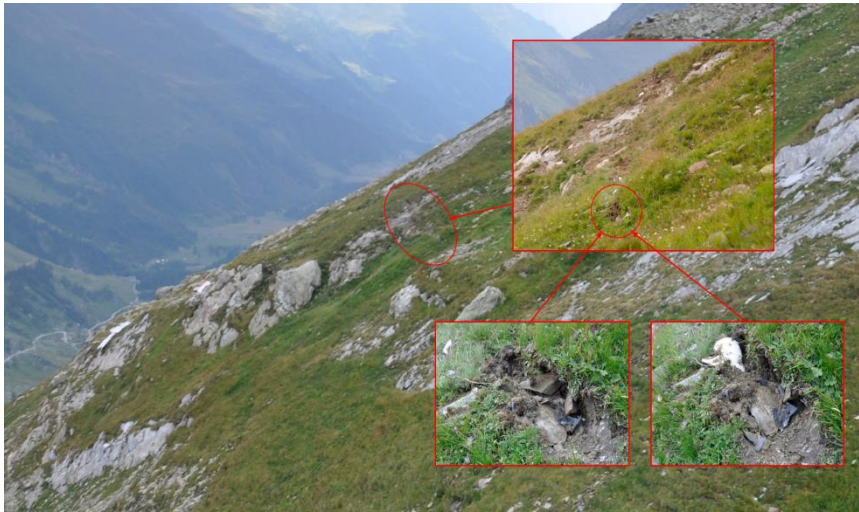
Evidence on the ground indicate that the glider initially impacted the slope with the bottom of the fuselage. No traces have been found before such point of impact, referable to ground contacts with the wings.

Photo 3: initial point of impact.

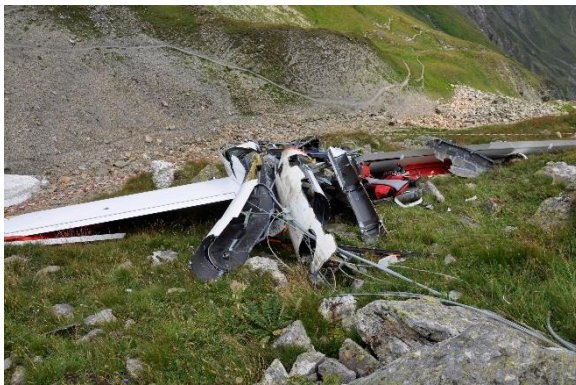
The main wreckage lied inverted, position indicative of a flip over, consistent with the eyewitnesses statements acquired.

Photo 4: main wreckage.

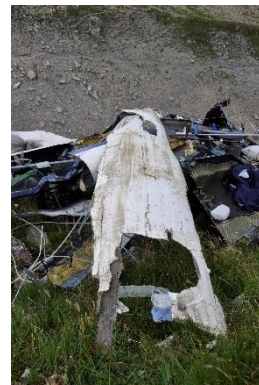
The conditions of the main wreckage confirmed what indicated by the ground evidence: the lower part of the fuselage and the flight control rods and linkages showed a high degree of destruction and deformation, while the wings resulted to be relatively intact.

Photo 5: lower fuselage.

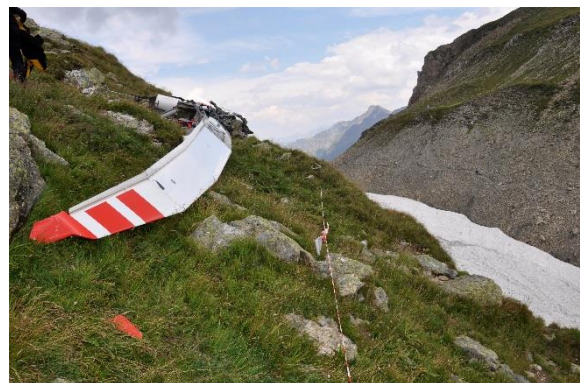
Photo 7: right wing.

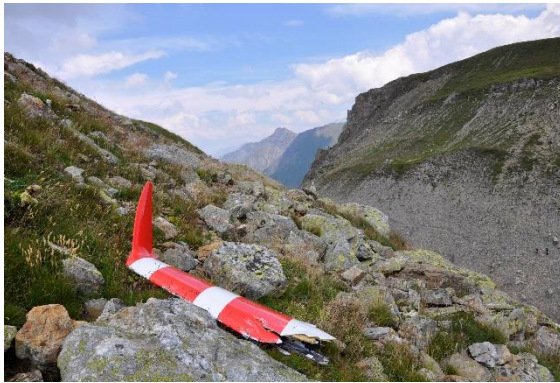
The detachment of the external section and the damages on the leading edge of the right wing let assume that it impacted with the ground at a point following the first contact with the ground, which occurred, as already said, with the lower part of the fuselage.

Foto 8: right wing outer section.

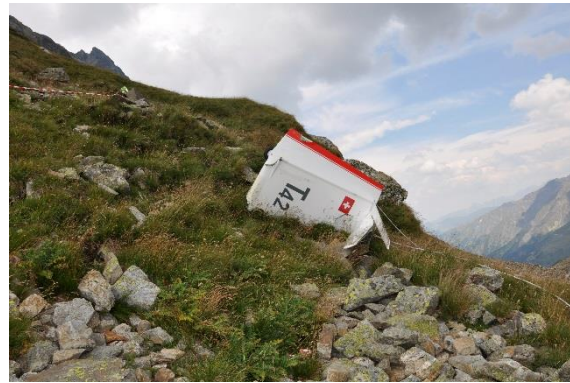
Photo 9: tail.

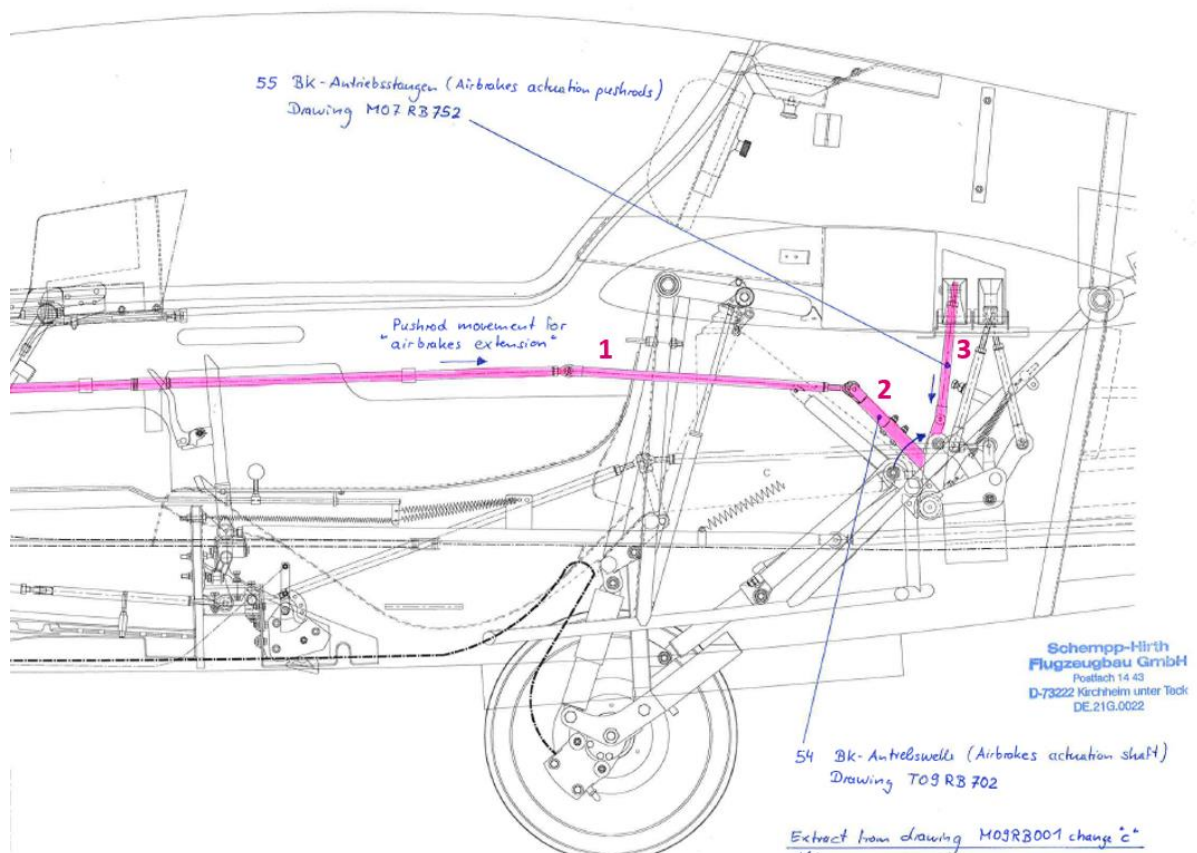
Regarding the latter, following the impact, the pushrod to the torque shaft (image 13, detail 1) transmitted a movement in the direction of airbrakes extension to the other shaft and pushrods (image 13, details 2 and 3).

The pushrod P/N M07RG752 (detail 3) applied a downward movement to the funnel which commanded the airbrakes crankshaft, that was much higher than the one applicable by the pilot with the cockpit lever. This movement brought into contact the funnel with the oblique arm of the left airbrake crankshaft, causing the funnel deformation and the crankshaft rotation axis breakage (photos 16 and 17).

Image 13: airbrakes pushroads and shafts from cockpit to funnel (glider left side).

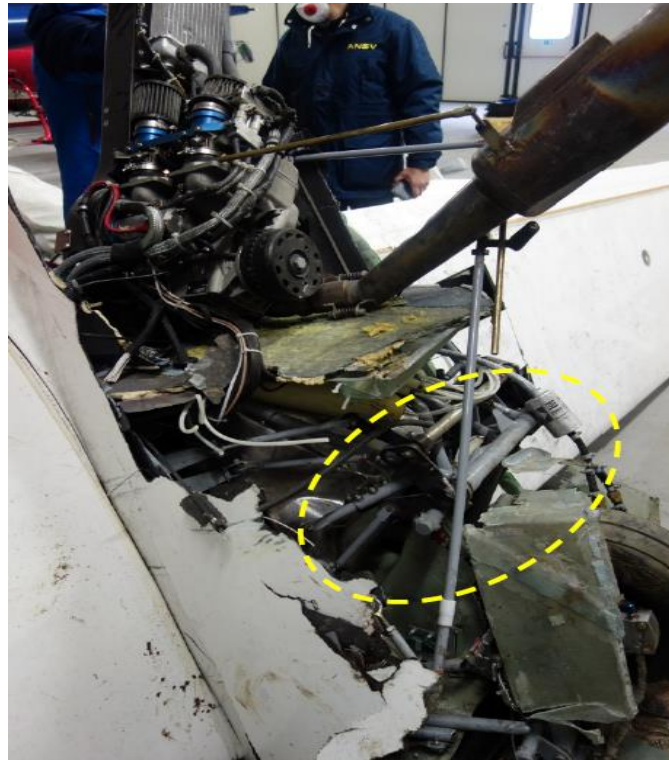
The airbrakes control chain was completely disarticulated from the airbrake levers in the cockpit up to the torque tube; the latter and the connection that brings the inputs to the funnel that rotates the relative crankshaft were heavily deformed (photos 12 and 13).

Photo 12: airbrakes *torque tube* damages.

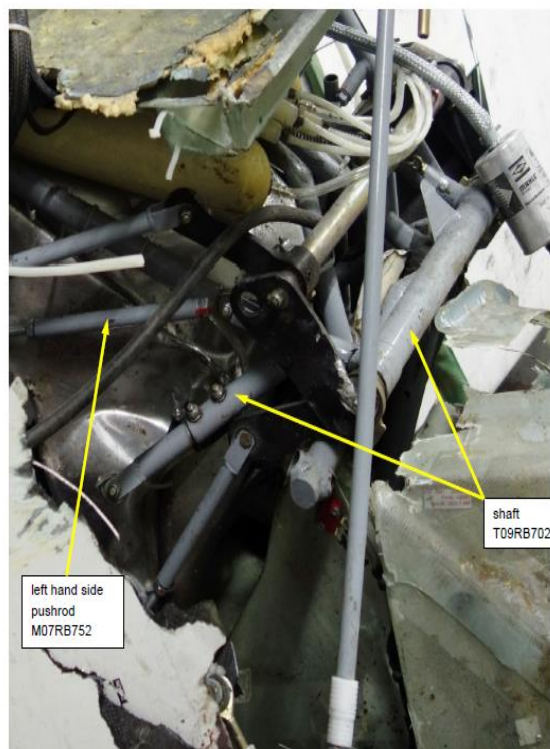
Photo 13: airbrakes pushroad and torque tube.

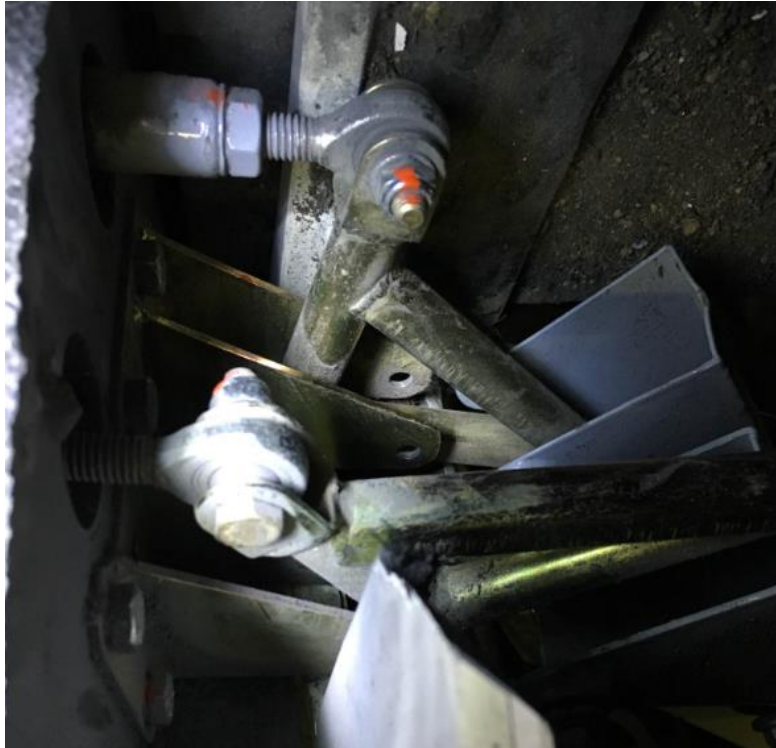
The crankshaft rotation pin was not found in place on the airbrake crankshaft of the left wing; the same pin and the relative bush have not been found inside the lower fuselage, which was open to the outside due to the damage cause by impact (photo 14).

Regarding the absence of the crankshaft rotation pin, it is believed that this is due to the destructive impact of the glider with the ground, in particular of the front and bottom fuselage structures, with strong involvement of the airbrakes control rods and levers.

Photo 14: left wing airbrakes *crankshaft*, rotational axis missing.

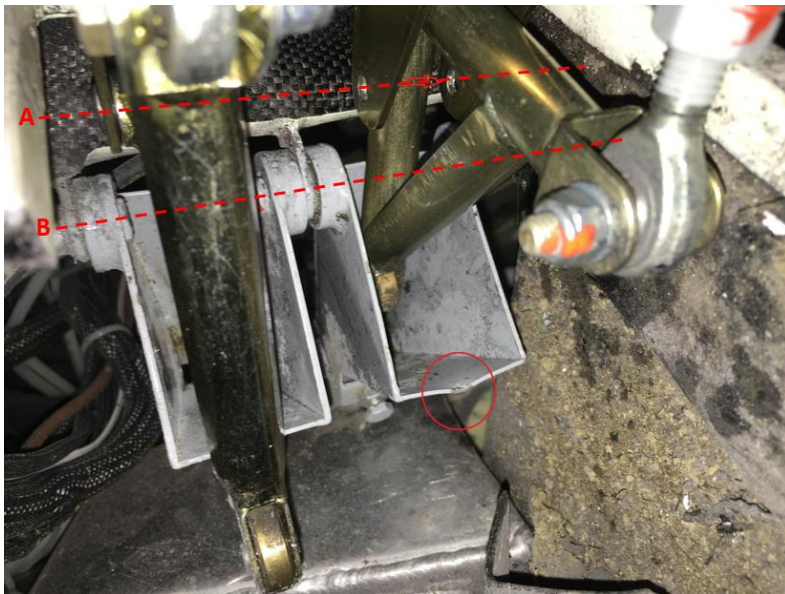
The stress received on impact was greater on the left wing flight controls chain, as suggested by the funnel deformation and loss of coaxiality between the funnel and crankshaft rotation axis on the left wing (photo 15); such damages are instead absent on the corresponding components of the right wing.

Photo 15: left wing airbrakes and flap *funnel* e *crankshaft* rotational axis misalignment.

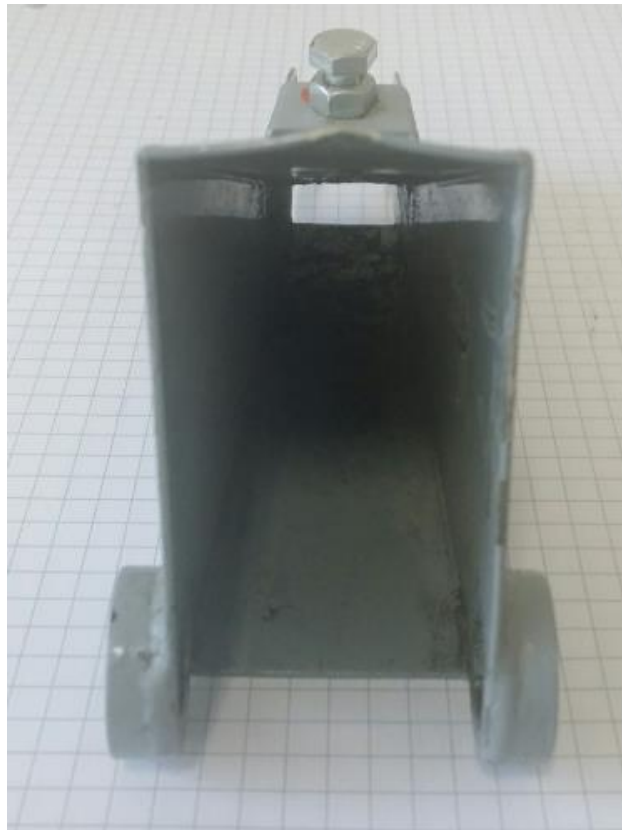
Foto 16: left wing crankshaft *funnel* damaged.

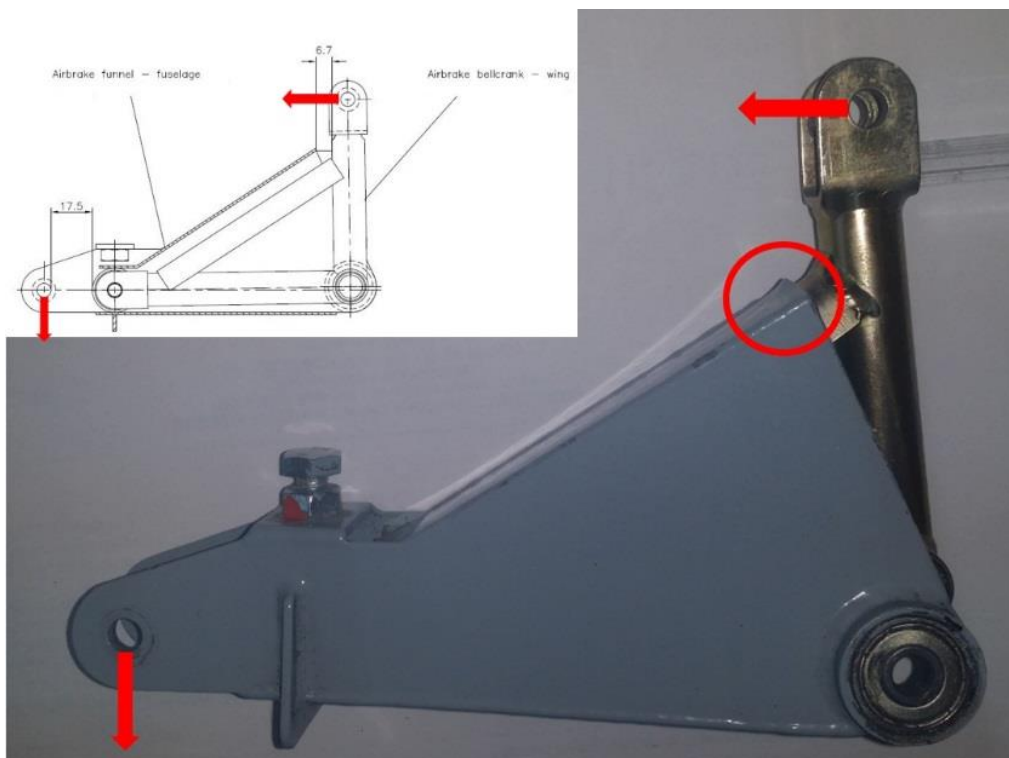
Photo 17: left wing *funnel* deformation due to contact with *crankshaft* (airbrakes extraction input).

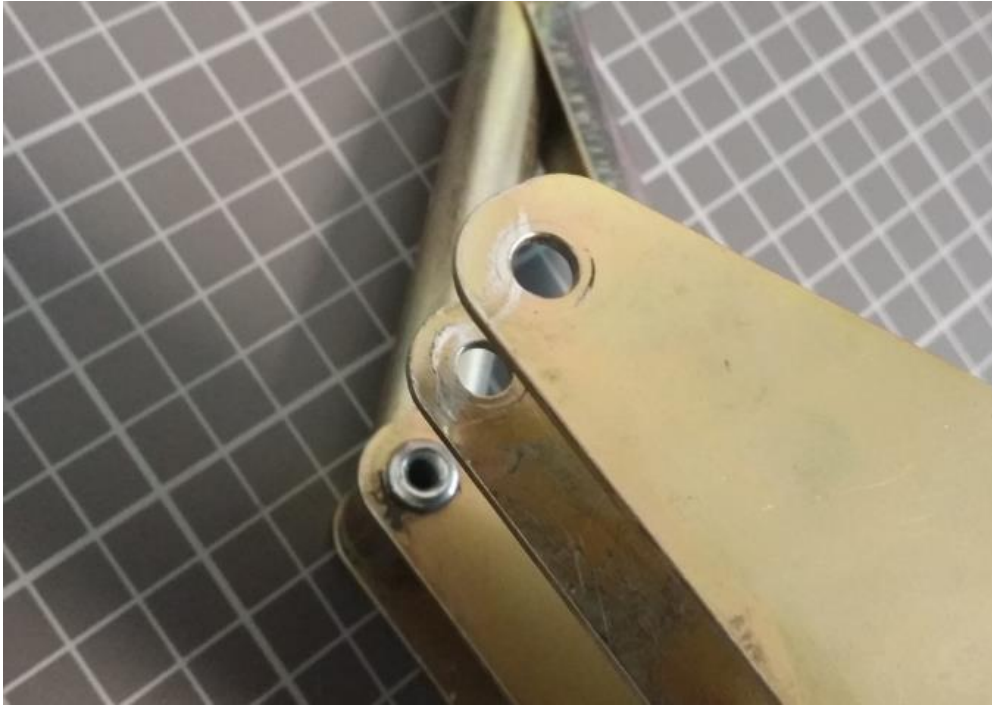
The supporting elements of the left airbrake crankshaft, showed clear signs of the presence of the rotation axis (photo 18), the support bending is due to the forces applied by the impact on the crankshaft, via its rotation axis that, before the breakage, produced the supports deformation (photo 19).

Photo 18: traces of rotational axis on left wing *crankshaft* supports.

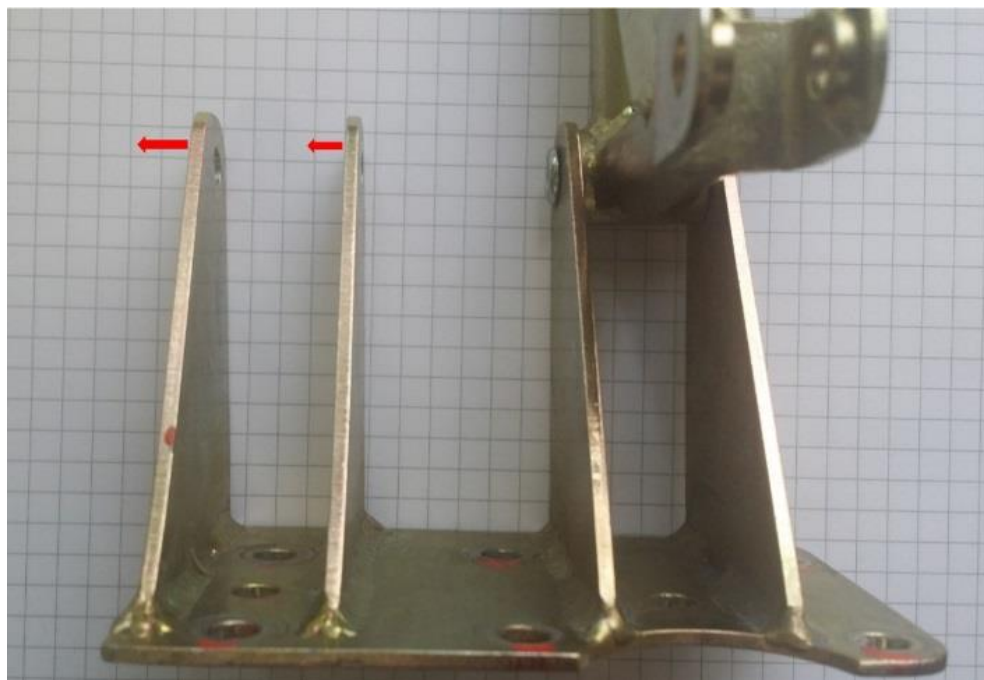
Photo 19: lateral bending of left wing *crankshaft* supports.
