FINAL REPORT

ACCIDENT
self-launching powered glider
Arcus M registration marks HB-2503,
Col Ferret, Courmayeur (Aosta, Val d'Aosta),
August 12th, 2015

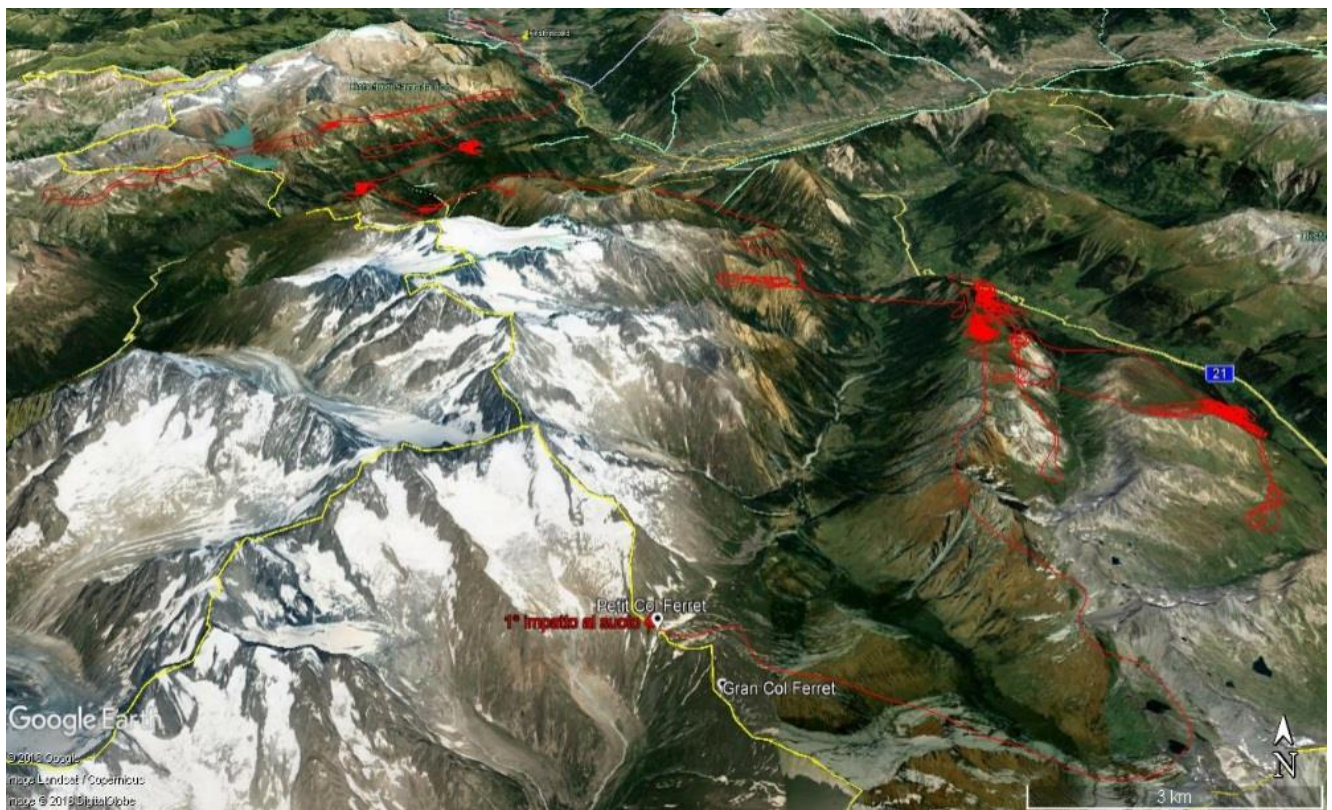
Image 1: HB-2503 flight path (on Google Earth).

- then it made three turn, the first to the left, then to the right and the last turn to the left, to align with Petit Col Ferret (during such turn, it impacted against the West slope of Petit Col Ferret, as shown in image 1). In this last phase of flight, the GS increased from 130 to 163 km/h, with a loss of altitude of about 30 m in the last 4 seconds (images 4, 5 and 6). During the last turn, the wind direction, initially from the right, rotated and came from the glider tail (direction 041°, intensity 8 km/h).

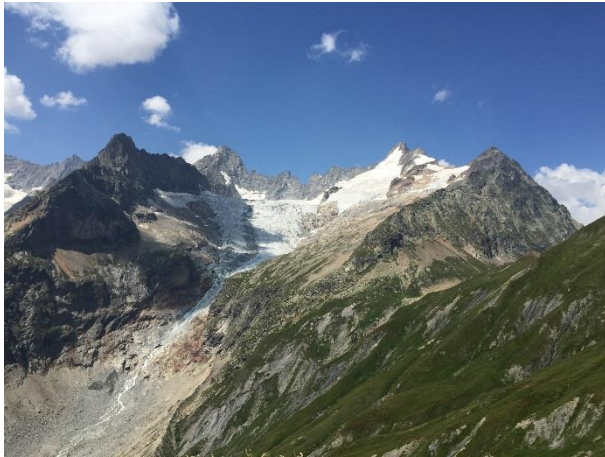
Photo 10: Petit Col Ferret at 12.24'.

From photos of Petit Col Ferret, taken by eyewitnesses, shot at 12.24' and 12.43' (9 minutes before and 10 minutes after the accident), the area appears in full sun and substantially free from clouds (photos 10 and 11).

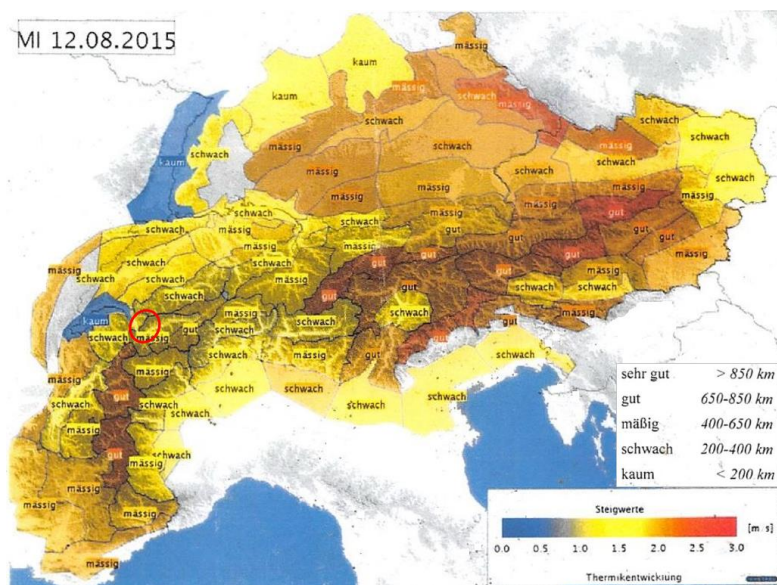
Image 8: thermal intensity forecast.

The map relating to the quality of thermals, found on board of the glider, indicates the presence of good quality thermals in the area flown by HB-2503 (image 8).

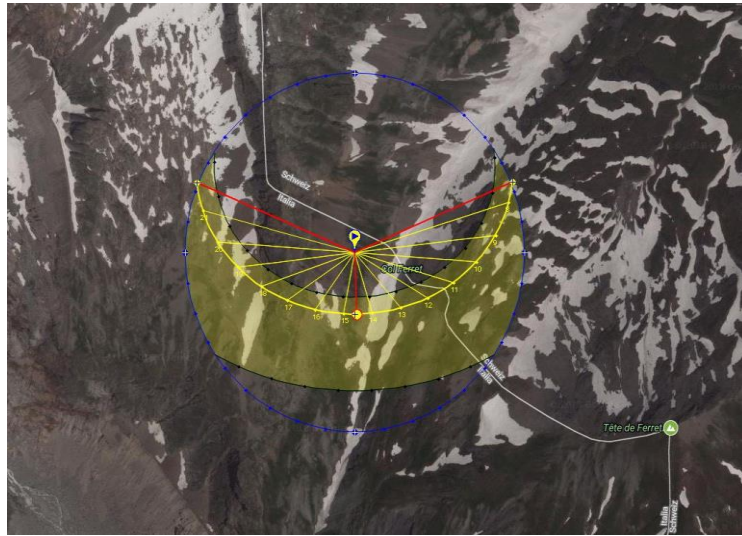
Image 9: sun position with respect to the last HB-2503 recorded flight position.

At the time of the accident the sun had an azimuth of 177° and an elevation of 59° (images 9 and 10).

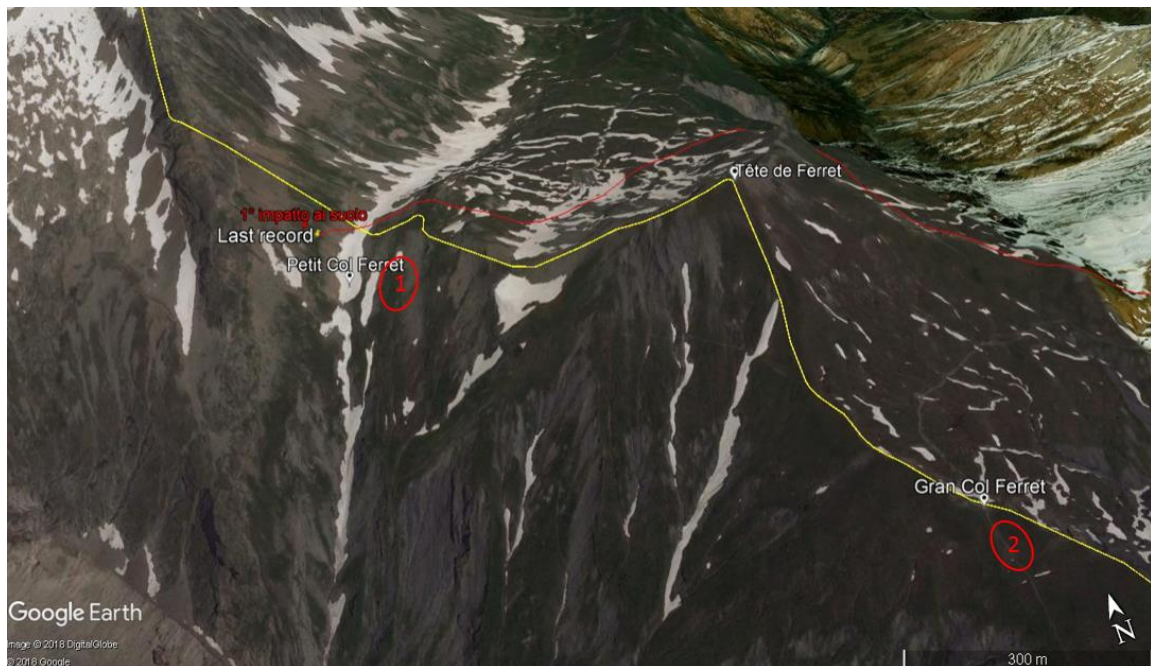
Image 11: eyewitnesses position with respect to the accident site (on Google Earth).

The three eyewitnesses, a single person and a couple, were located, respectively, close to Petit Col Ferret and Gran Col Ferret (image 11, positions 1 and 2).

Two of the witnesses (image 11, position 2) also declared that they saw the aircraft lowering both wings, alternately on right and left, seconds before the impact. They also added that they perceived strong frontal wind, coming from NE, once they reached the top of the Gran Col Ferret, so strong that they initially thought it could have been the cause of the accident.
